SITE INSPECTION ML 47280

Lease #: O,G & H, ML 47280

Lands Inspected: SW4SW4NW4 and S½NW4SE4 of Section 32, T.5S., R.22E.,

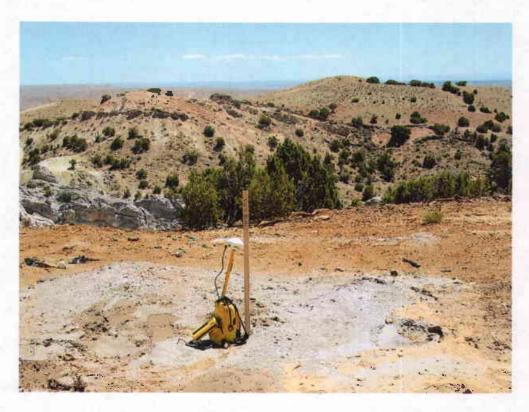
ML 47280 - 5-31-06, Looking south onto a drill hole at UTM coordinates N 4466564.24, E 629267.78. This hole is in a area with numerous roads that is apparently used as an offroad recreation area.

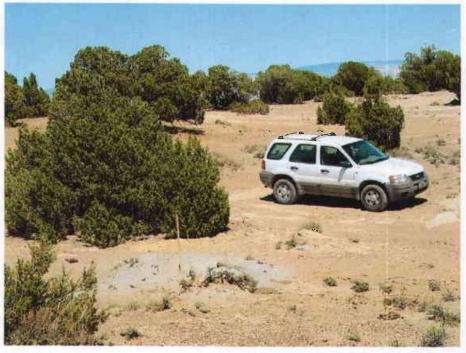
ML 47280 - 5-31-06, Second drill hole found south east of the drill hole shown in the previous picture. UTM coordinates for this hole are: N 4466547.53, E 629368.56.

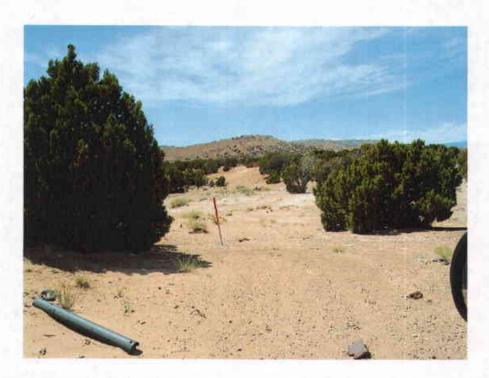
ML 47280 – 5-31-06, Typical survey marker found near the drill hole depicted in the previous picture. Similar survey markers were observed on other lease held by Black Sands Holding Co.

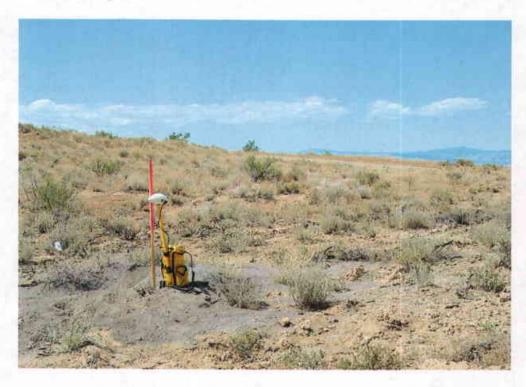
With in the S½NW¼SE¼ one drill hole was observed. This drill hole was covered in the same manner as previously mentioned and was estimated to be approximately 50 to 75 feet deep. All the drill holes observed appear to have been drilled using an 8 to 10 inch rotary-air drill rig as evidence by the diameter of the hole and the cuttings around the drill holes. Drill hole depth was estimated by dropping a stone down the drill hole and observing the time it took to hit the bottom of the hole. GPS-UTM coordinates were taken for the drill hole locations identified in this report.

ML 47280 – 5-31-06, A third drill hole found southeast of the other drill holes. The UTM coordinates for this hole are N 4466174.06, E 630335.07.
